**Guangdong Sushi Guangbo Testing
Technology Co., Ltd.**

Test Report

No.: GDGT-H/R-2019-459-EN

Product name: SOLAR INVERTER;

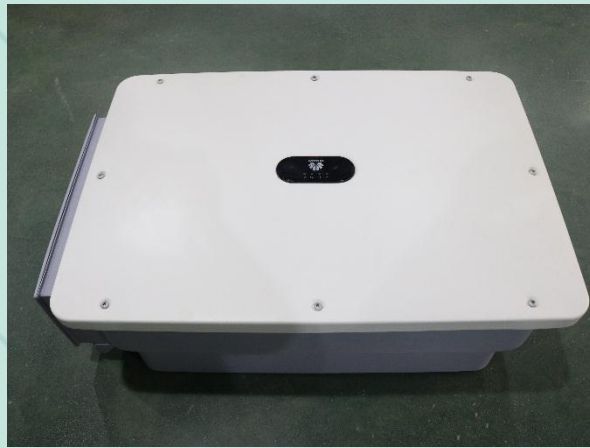
Fig 1 Appearance inspection before waterproof test

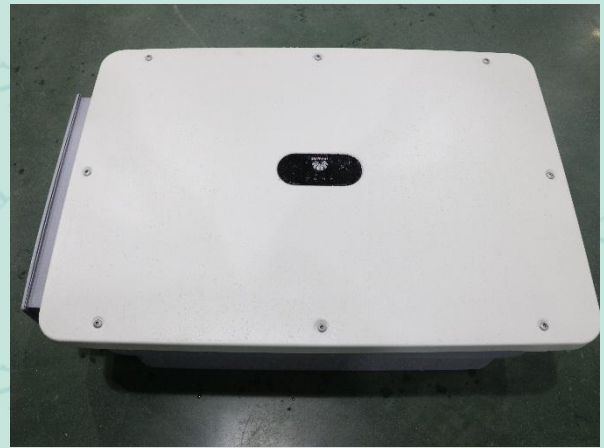
2.The tested samples have completed all the tests according to the conditions. After the test, there is no obvious change in the appearance of the samples and no water inflow is found inside.

Fig 2 Appearance inspection after waterproof test

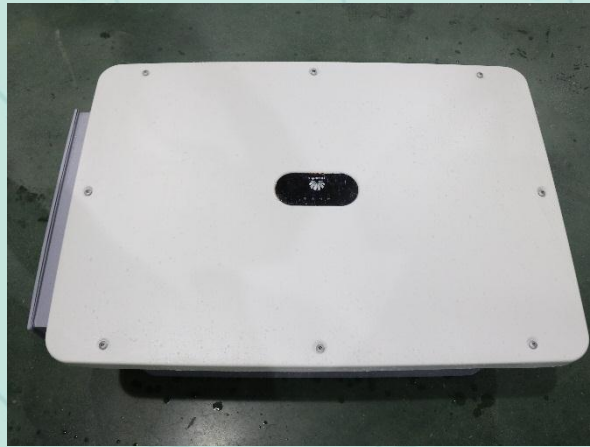
Fig 3 Appearance inspection before dustproof test

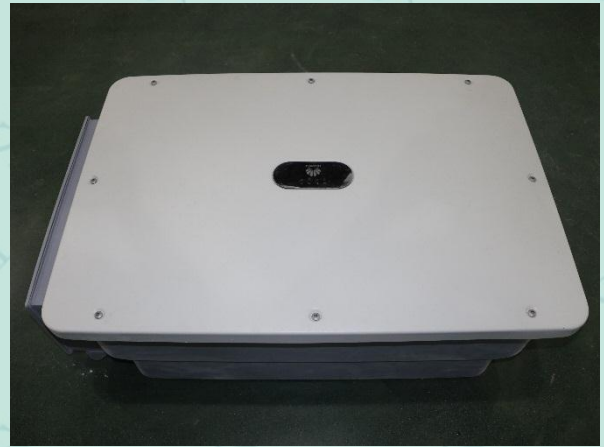
2. The tested samples have completed all the tests according to the conditions. After the test, there is no obvious change in the appearance of the samples, and no dust was found inside.

Fig 4 Appearance inspection after dustproof test

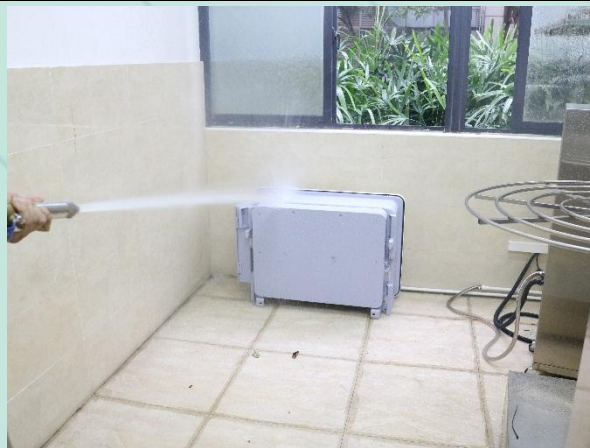
1. Water flow: 100L/min;
2. Nozzle distance from sample: 2.5m～3m;
3. Test of time: 3 minutes.

Fig 5 During waterproof test

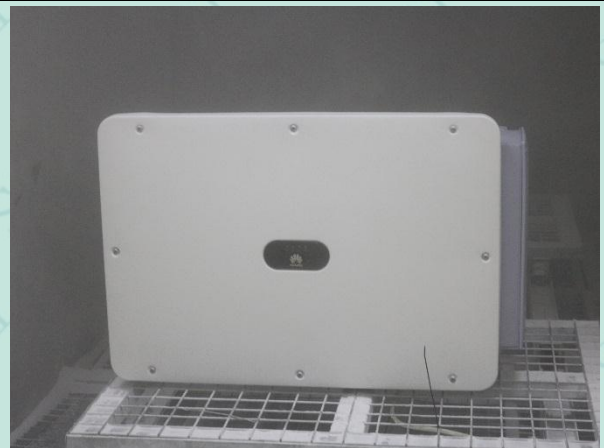
1. Talcum powder (2kg/m^3) ;
2. The sample shell is pumped with negative pressure;
3. Test of time: 8 hours;
4. The experiment was carried out twice.

Fig 6 During dustproof test
